FUNDAMENTAL INVESTIGATION OF FATIGUE CRACK GROWTH RETARDATION IN ALUMINUM ALLOYS

Northrop Corporation
Aircraft Division
3901 West Broadway
Hawthorne, California 90250

SEPTEMBER 1976

TECHNICAL REPORT AFML-TR-76-156

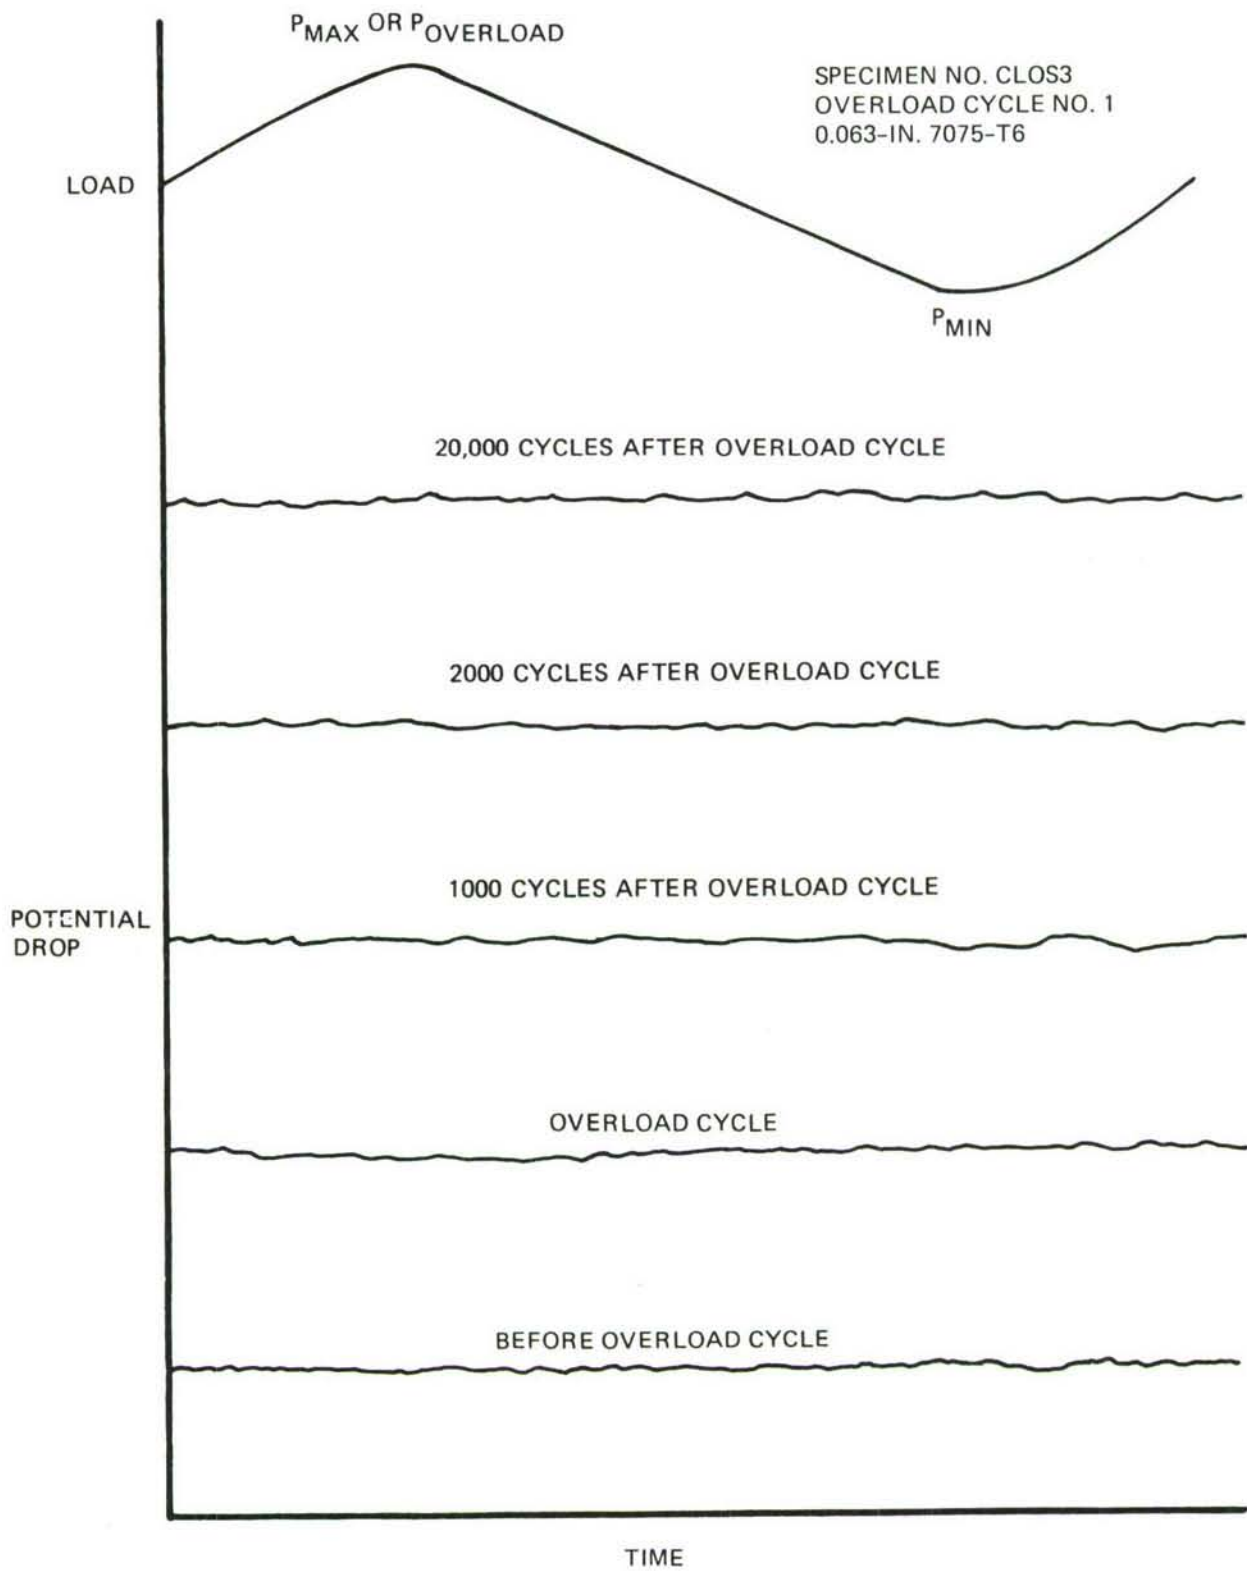
FIGURE A-8. POTENTIAL VS LOAD DURING AND AFTER OVERLOAD CYCLE
SHOWING NO CRACK-CLOSURE

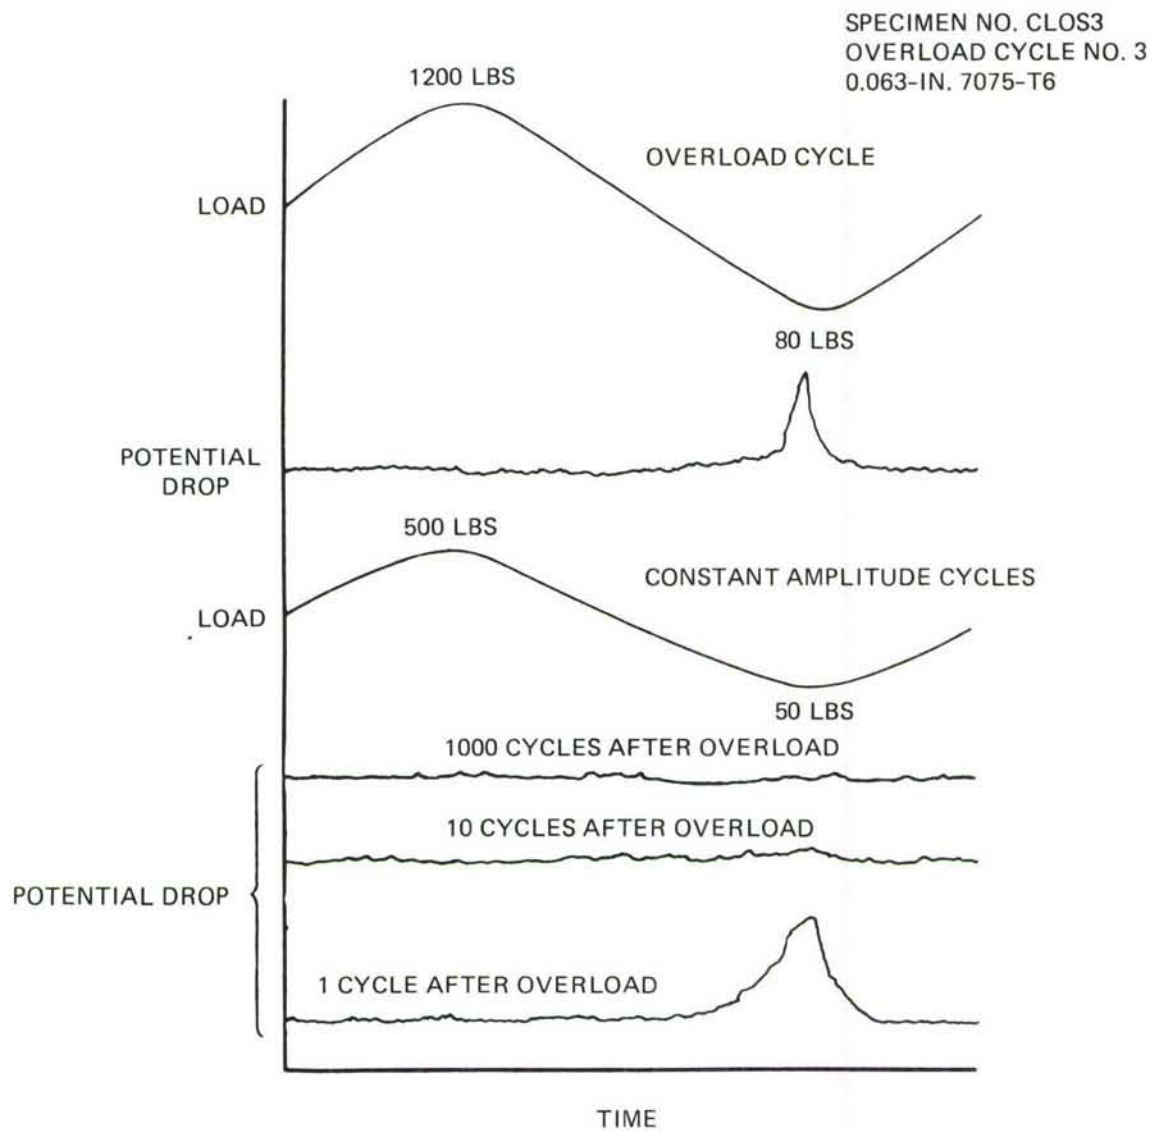
FIGURE A-9. POTENTIAL VS LOAD DURING AND AFTER OVERLOAD CYCLE – SHOWING CRACK-CLOSURE

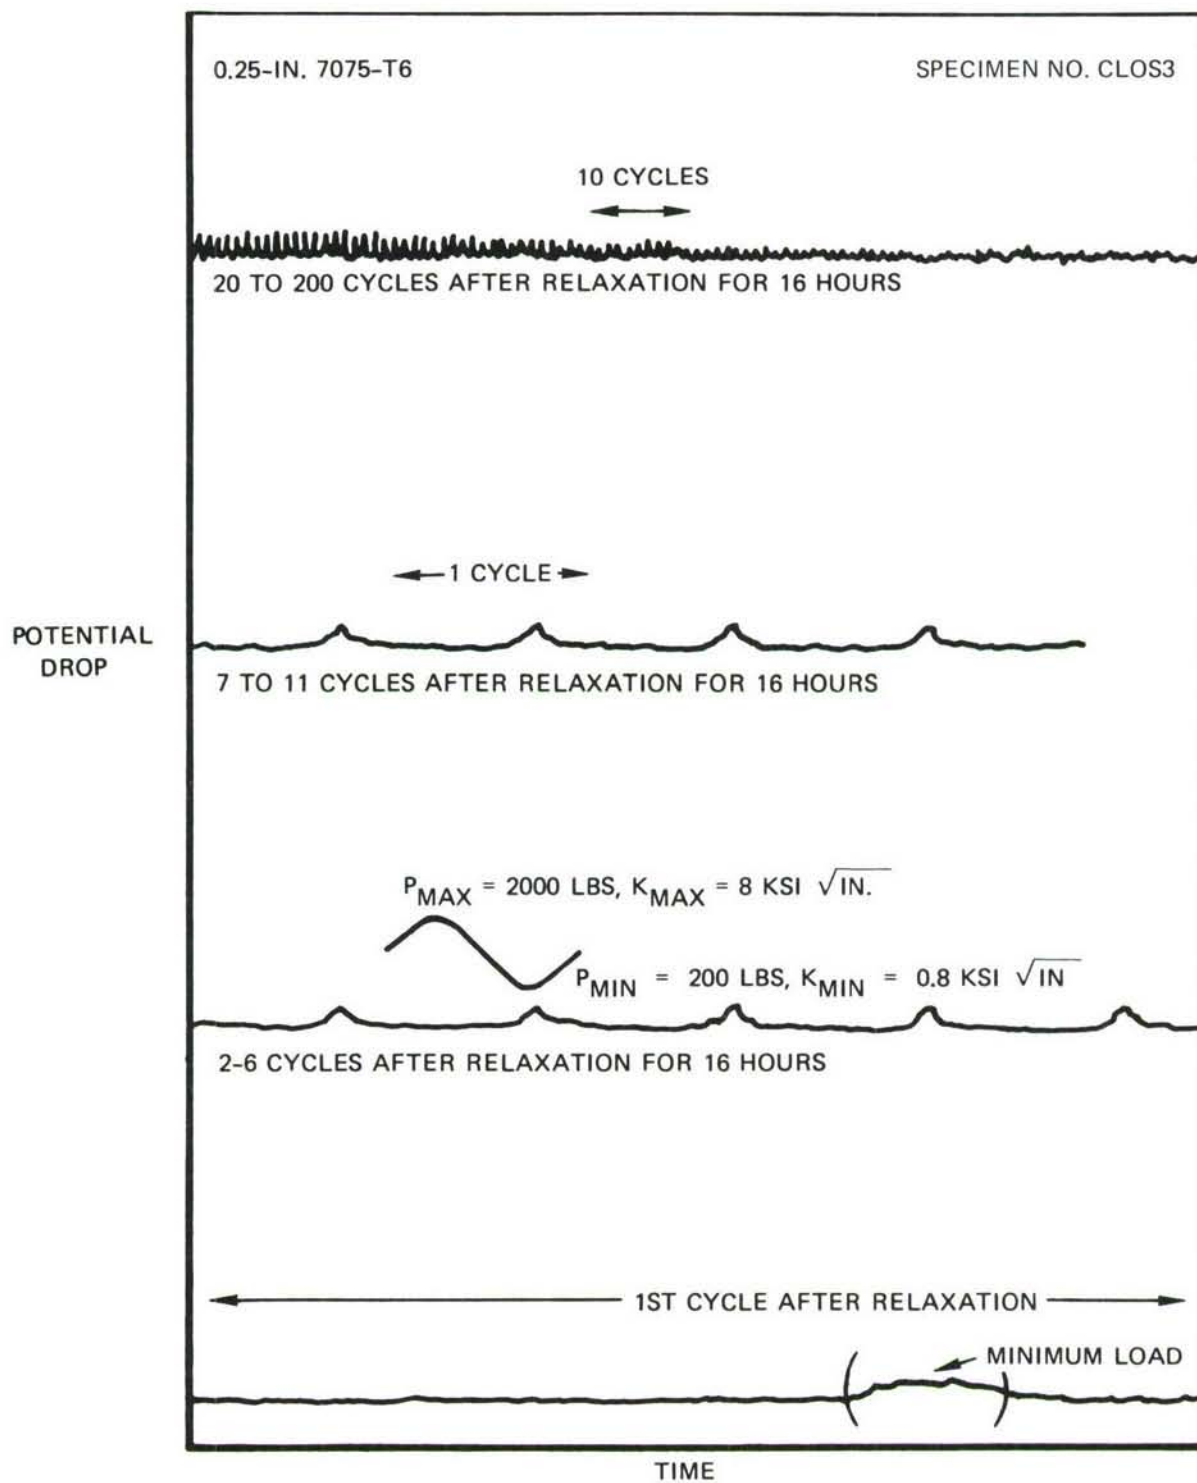
FIGURE A-10. EFFECT OF RELAXATION ON CRACK-CLOSURE

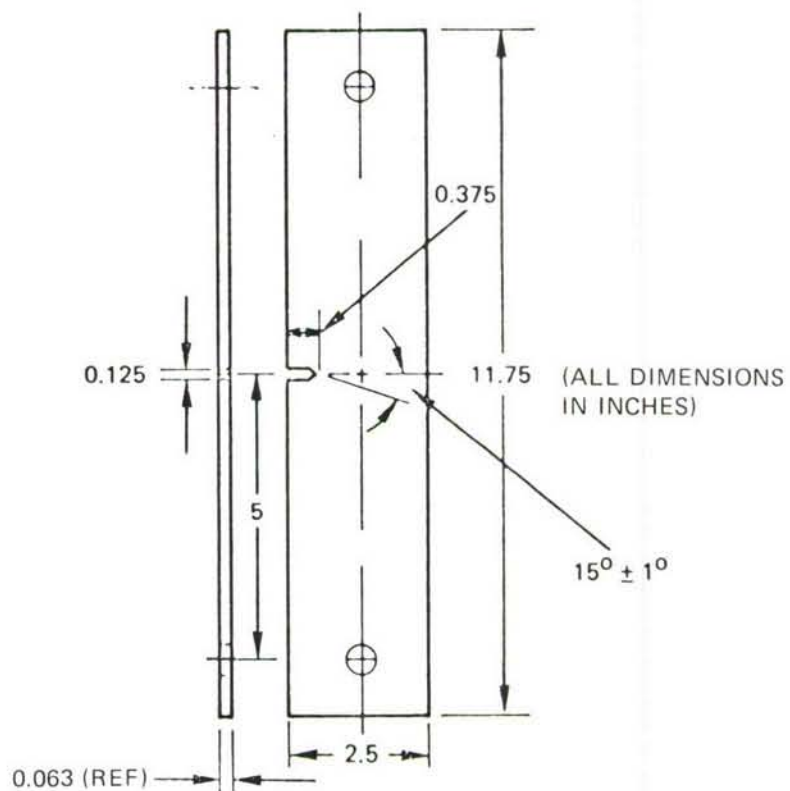
FIGURE C-1. SEN ALUMINUM SPECIMEN, LT (RW) ORIENTATION

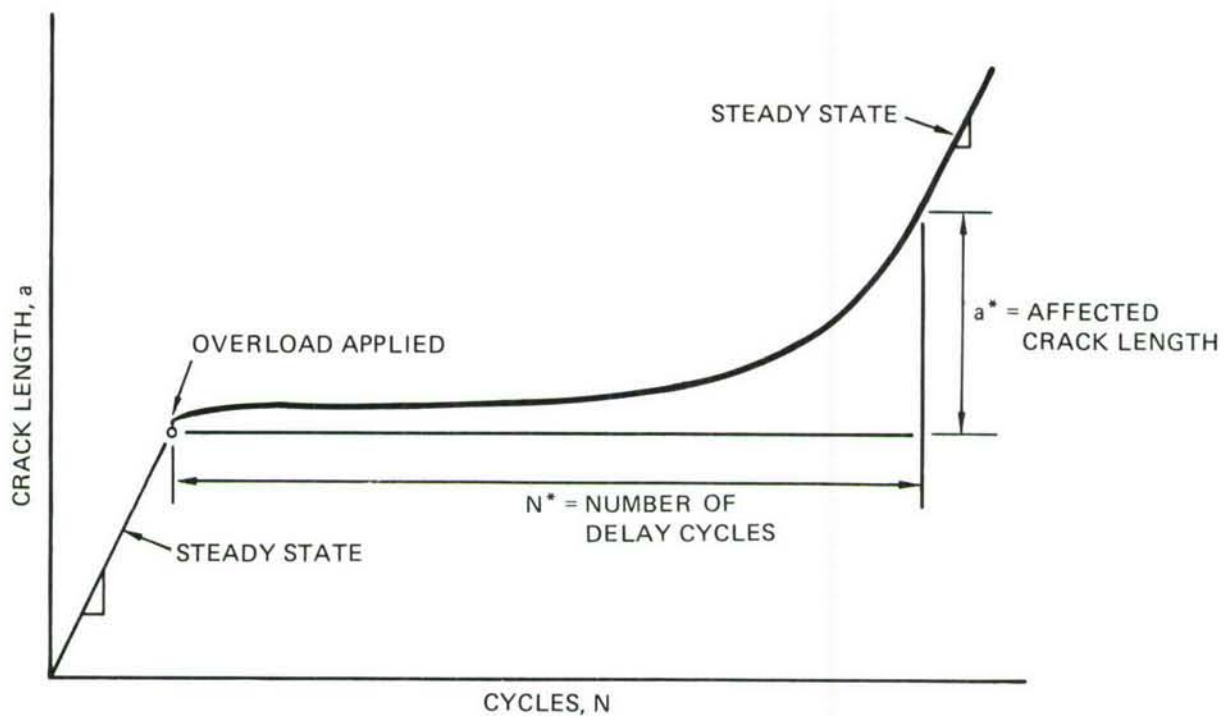
FIGURE C-4(a). CRACK-GROWTH RATE CURVE RESULTING FROM APPLICATION OF A SINGLE OVERLOAD

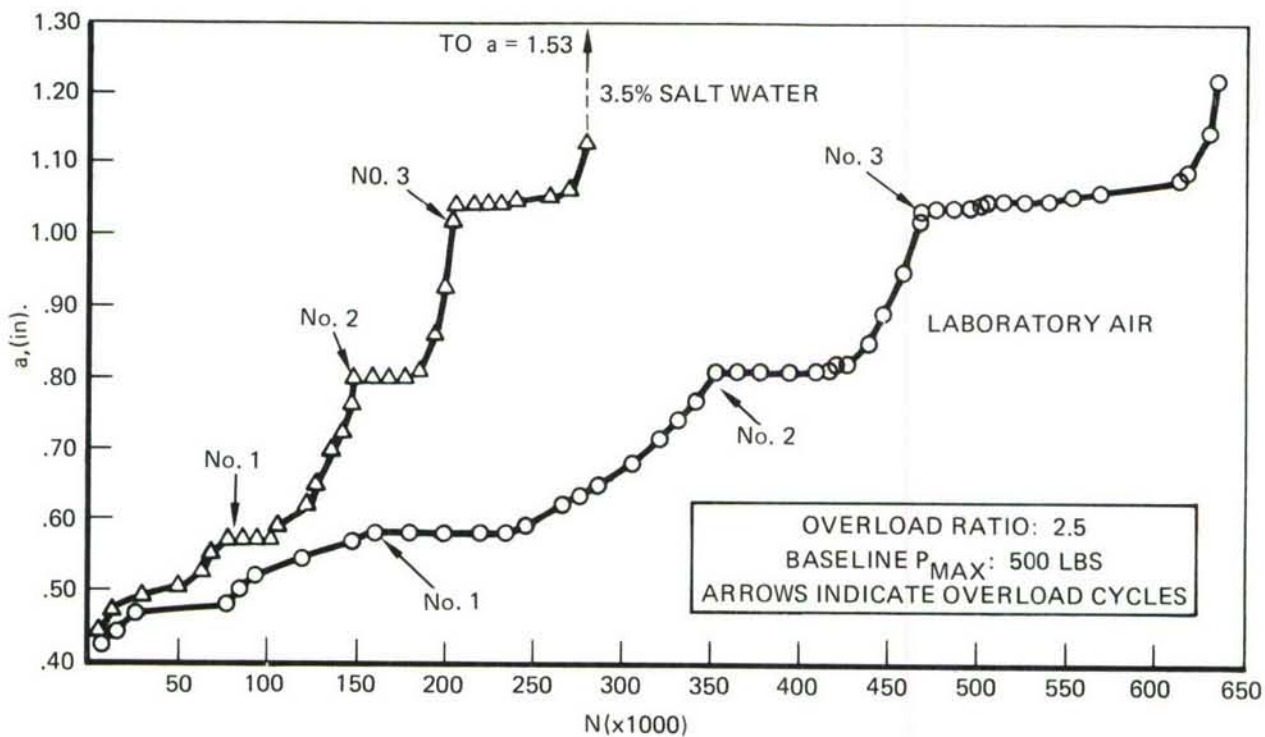
FIGURE C-4(b). CRACK-LENGTH VS NUMBER OF CYCLES FOR 7075-T73 ALLOY AT AN OVERLOAD RATIO OF 2.5 IN BOTH AIR AND SALT WATER

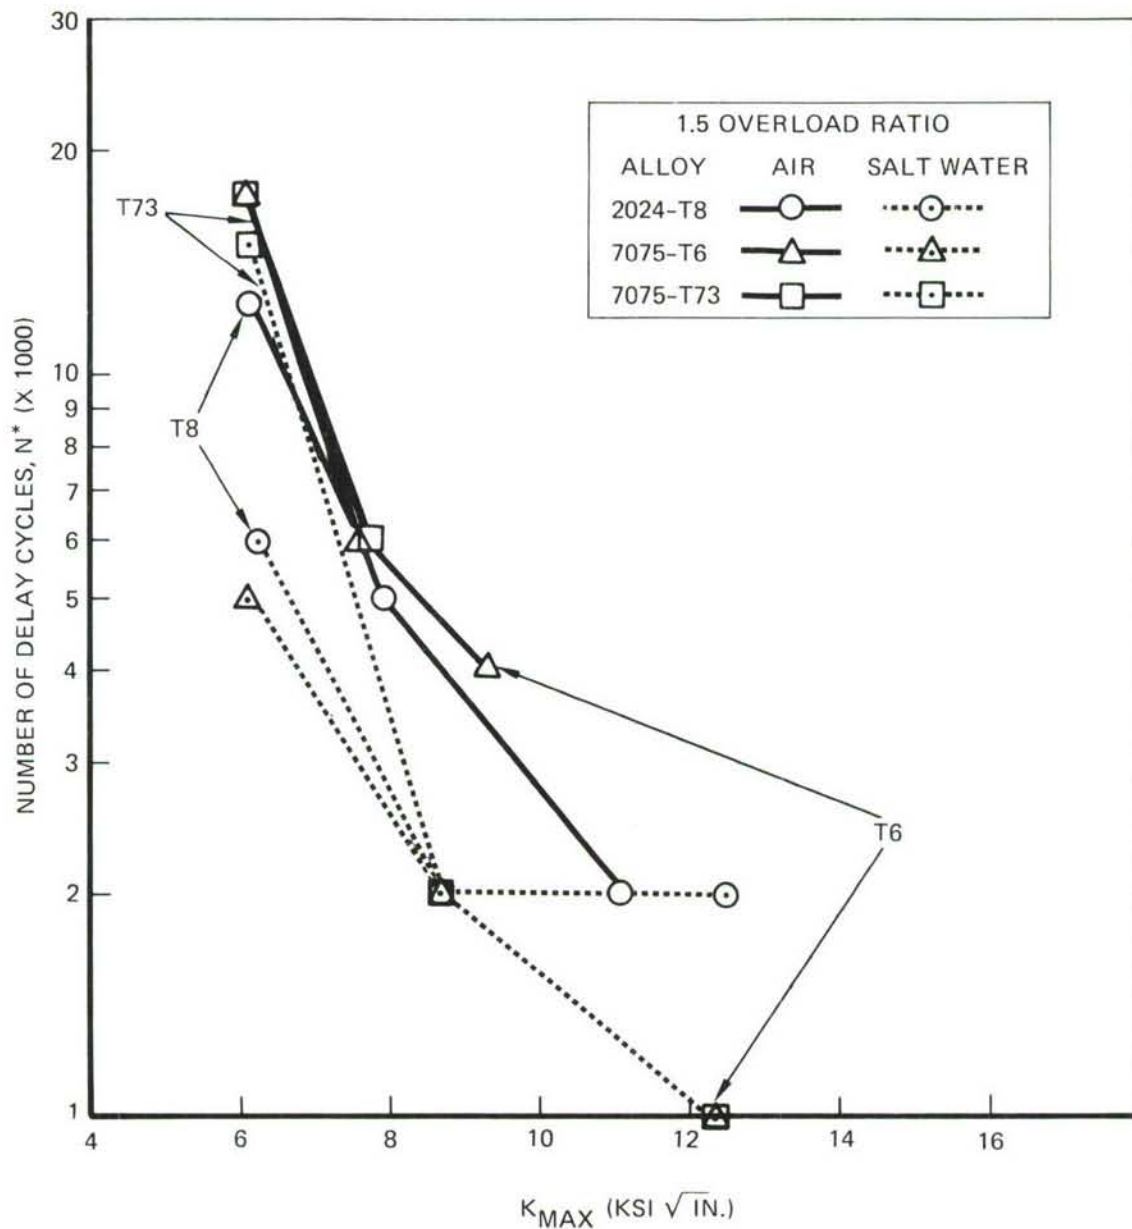
FIGURE C-5. NUMBER OF DELAY CYCLES AS A FUNCTION OF BASELINE STRESS-INTENSITY FACTOR IN AIR AND 3.5% SALT WATER AFTER AN OVERLOAD RATIO OF 1.5

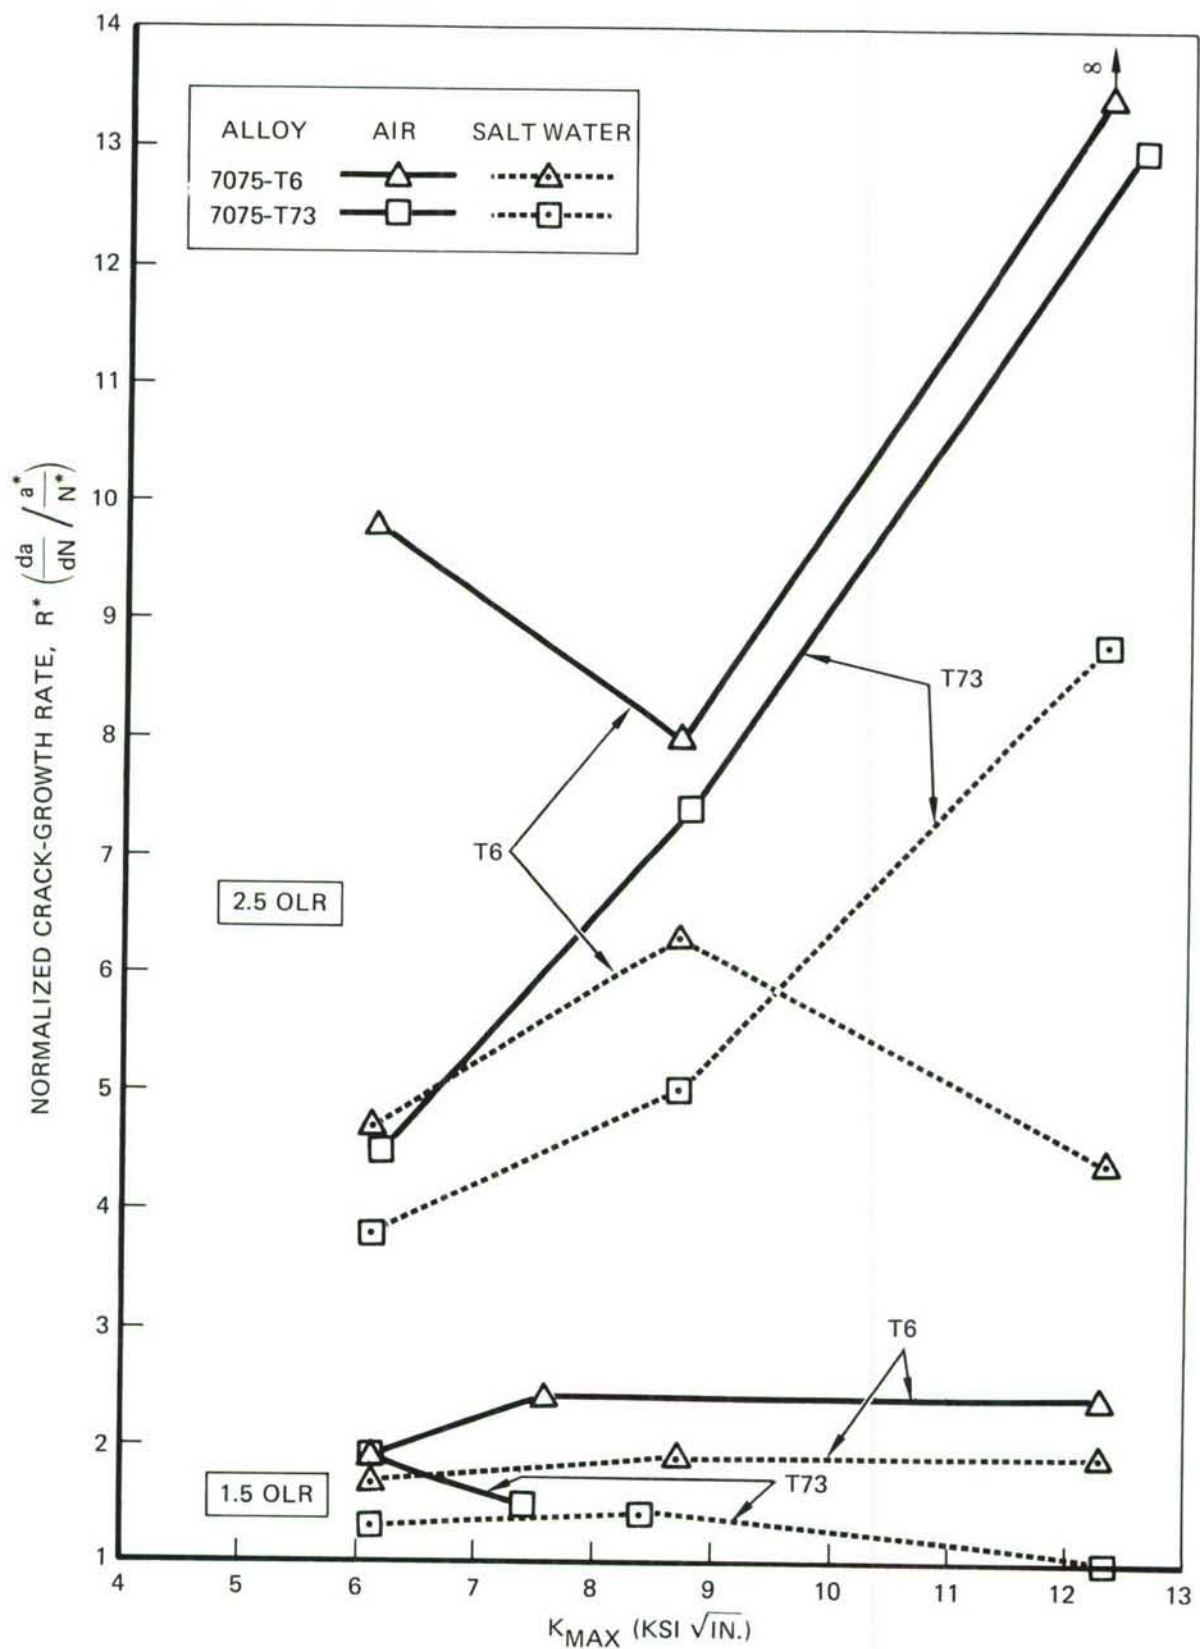
FIGURE C-8. THE EFFECT OF OVERLOAD RATIO (OLR) ON NORMALIZED AVERAGE CRACK-GROWTH RATE IN AIR AND SALT WATER FOR THE 7075 ALLOY

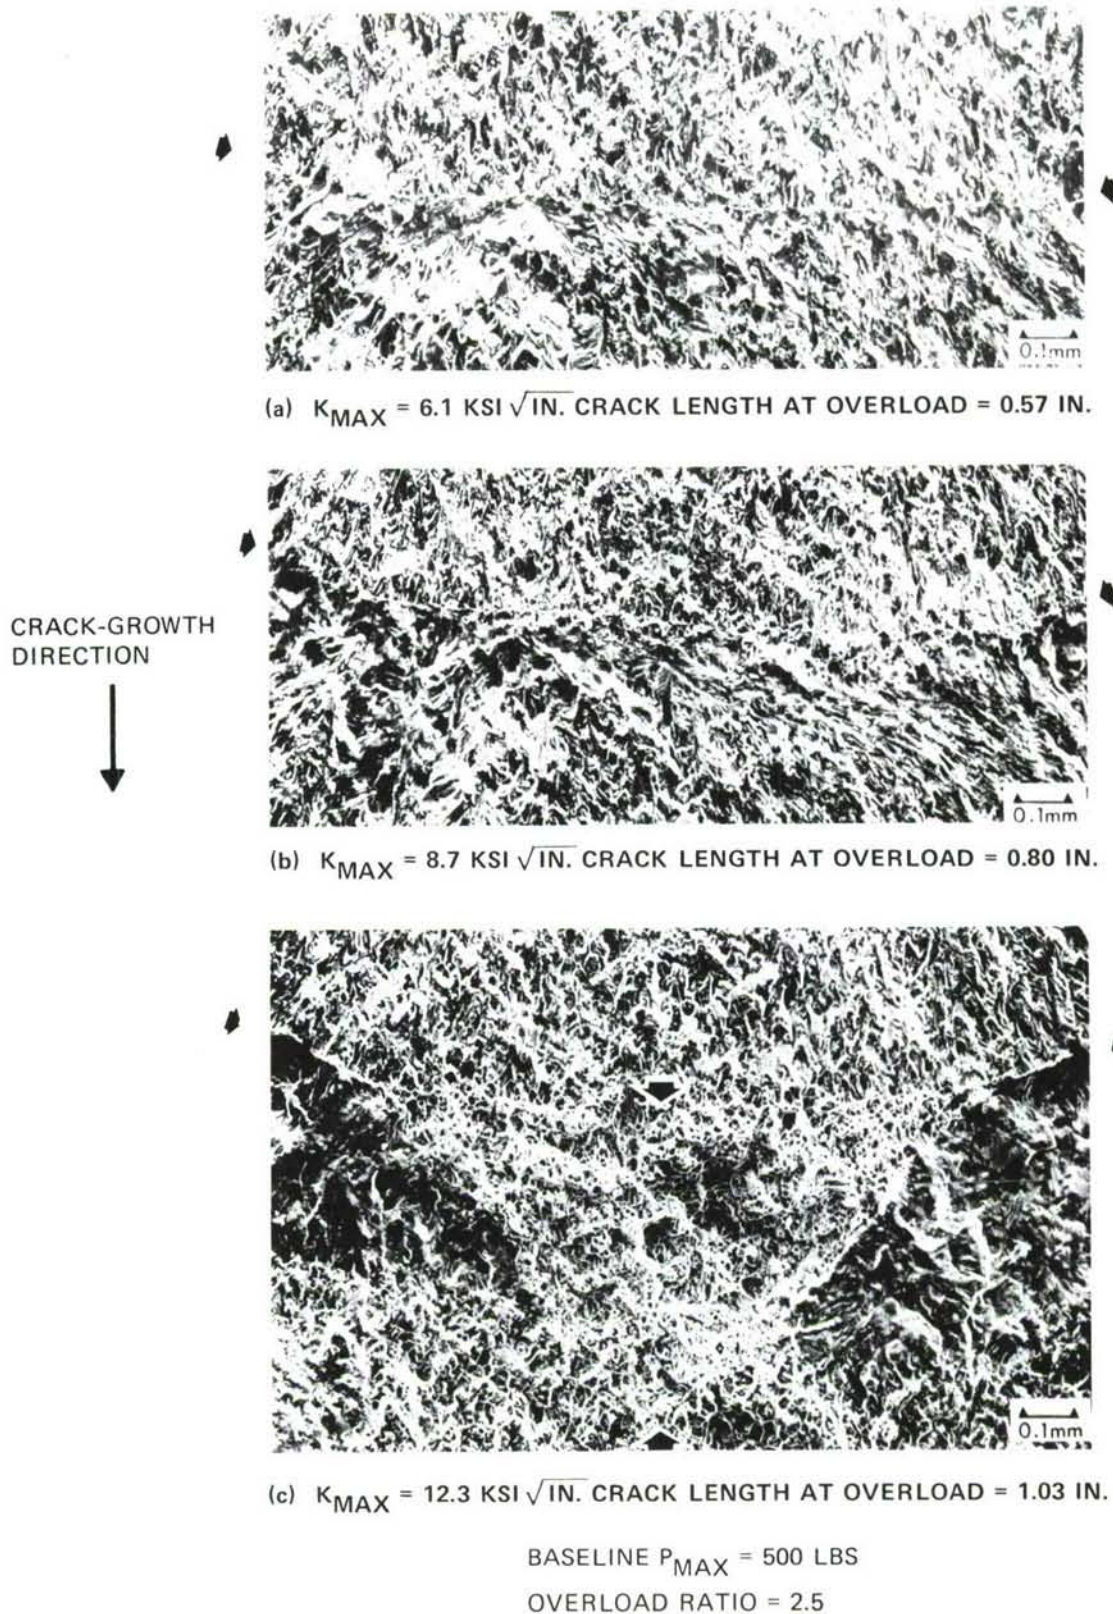
FIGURE C-9. FRACTOGRAPHS SHOWING EFFECT OF STRESS INTENSITY ON OVERLOAD MARKING AFTER A 150% OVERLOAD CYCLE IN 7075-T6 IN AIR

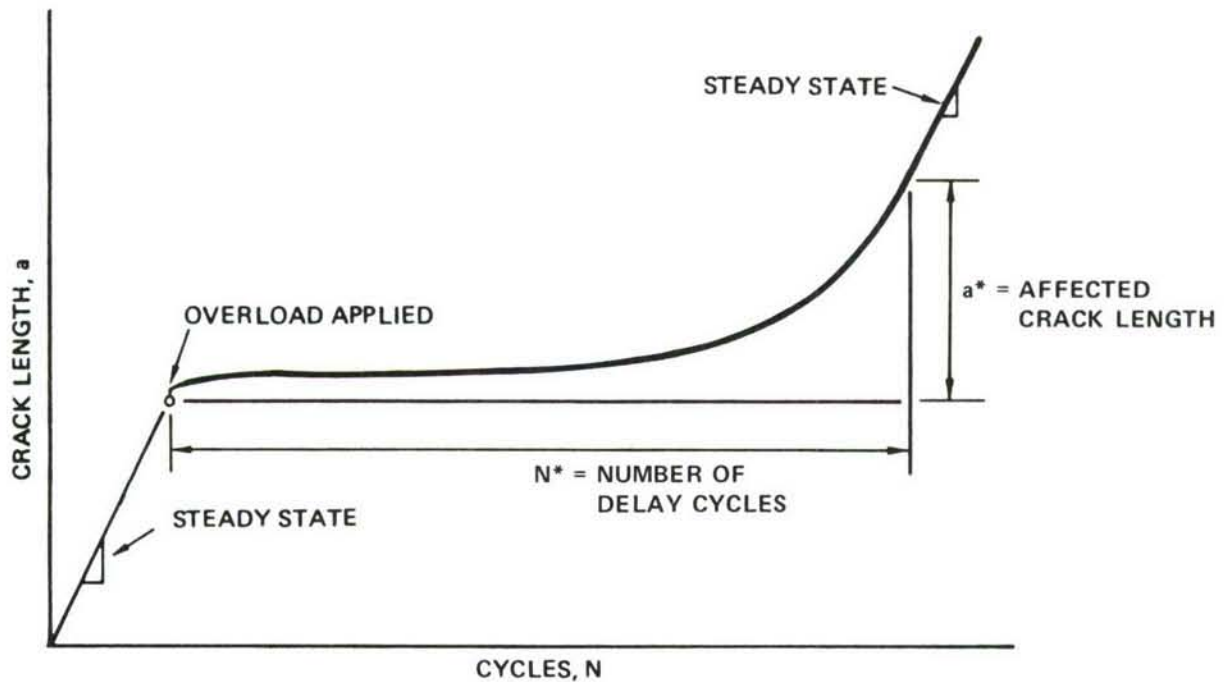
FIGURE D-3(a). CRACK-GROWTH RATE CURVE RESULTING FROM APPLICATION OF A SINGLE OVERLOAD

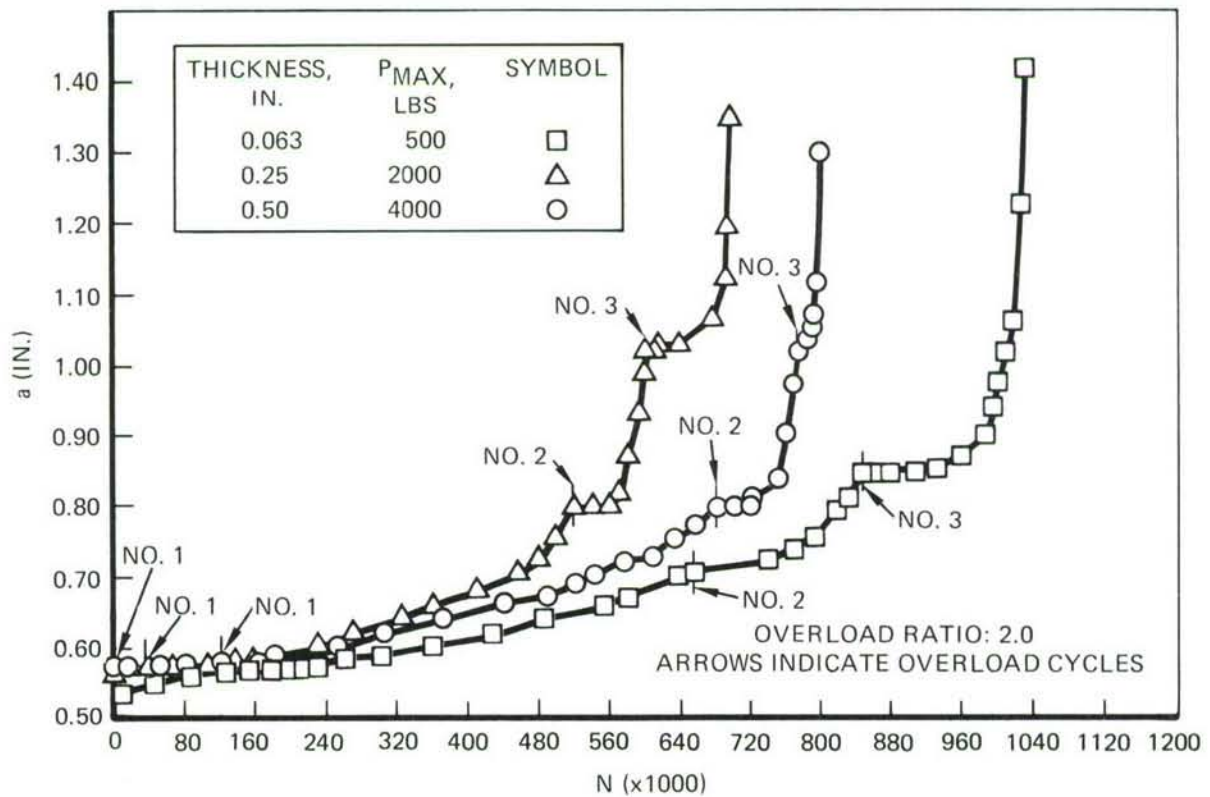
FIGURE D-3(b). CRACK-LENGTH VS NUMBER OF CYCLES FOR THREE THICKNESSES OF 2024-T3 ALLOY AT AN OVERLOAD RATIO OF 2.0

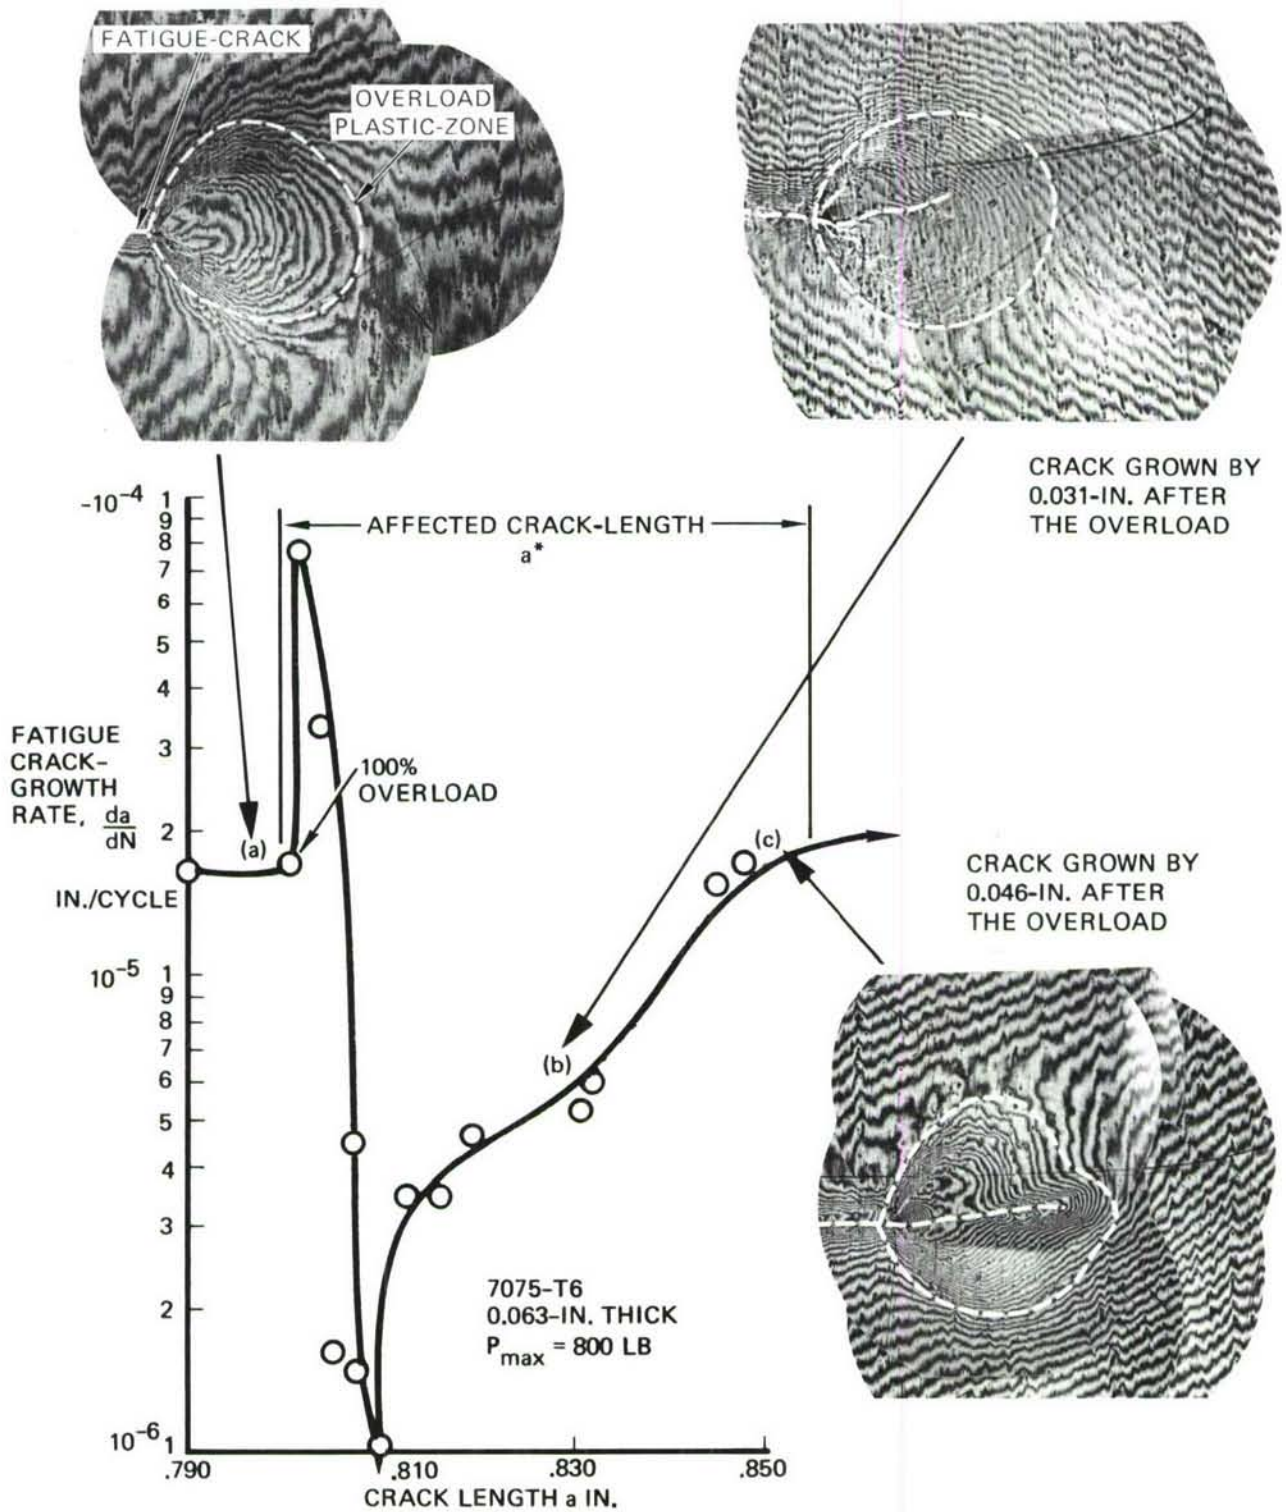
FIGURE D-10. INTERFERENCE PATTERNS AT DIFFERENT STAGES OF CRACK-GROWTH AFTER A 100% OVERLOAD CYCLE

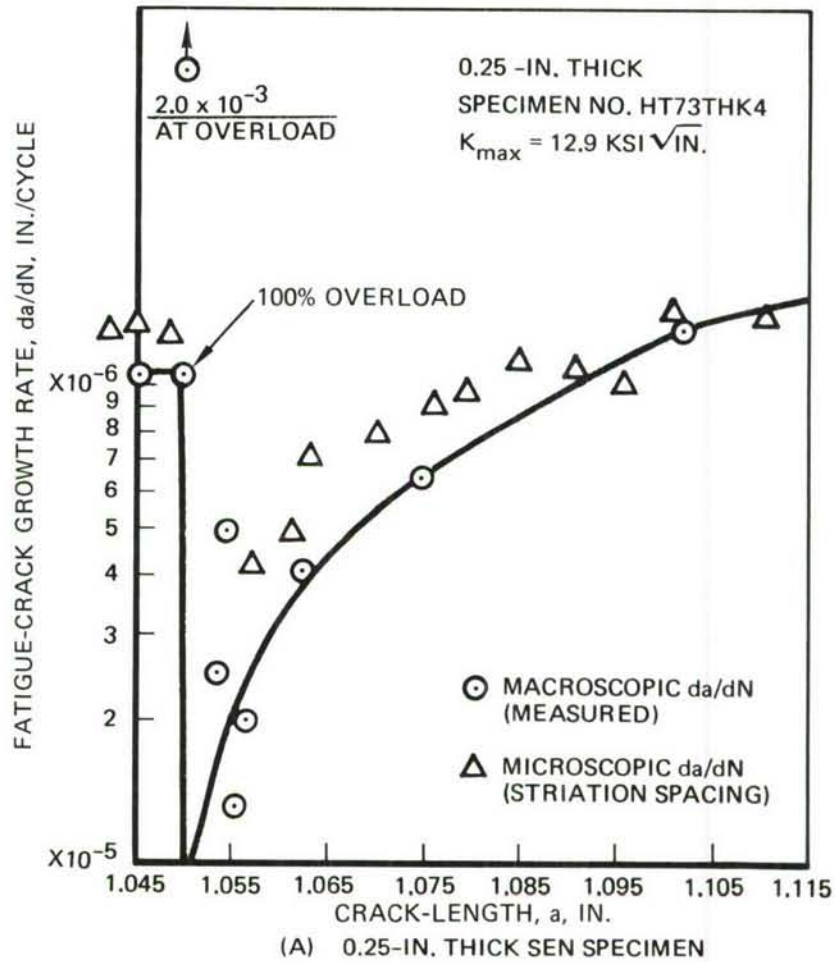
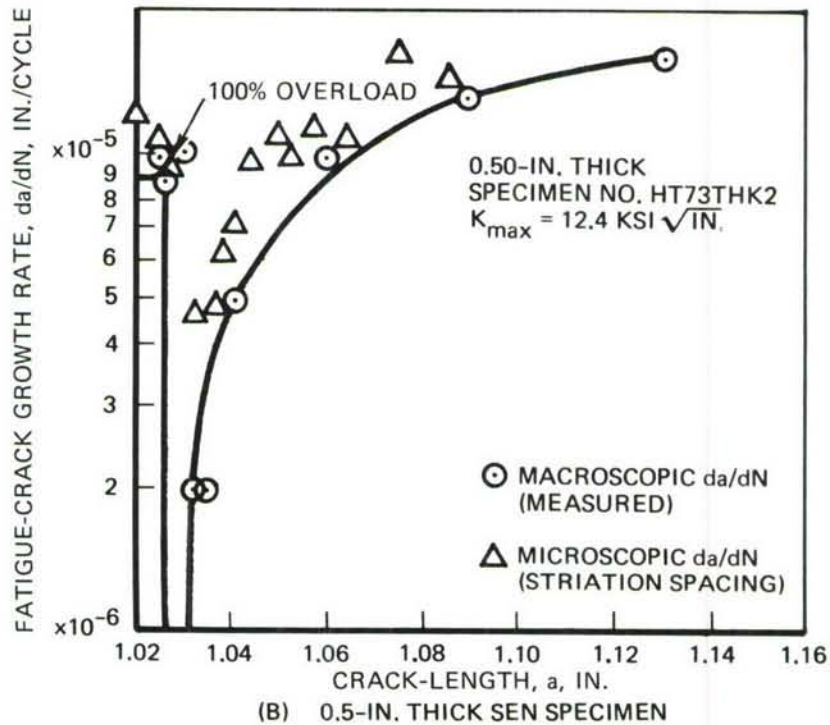
FIGURE D-14. MICROSCOPIC AND MACROSCOPIC CRACK-GROWTH BEHAVIOR AFTER 100% OVERLOAD CYCLE IN 7075-T73 ALLOY
